Guarto

**Maintenance Info MI291a
MP3 - Service Release SR2**

1 Maintenance Info MI291a: Guarto MP3 SR2

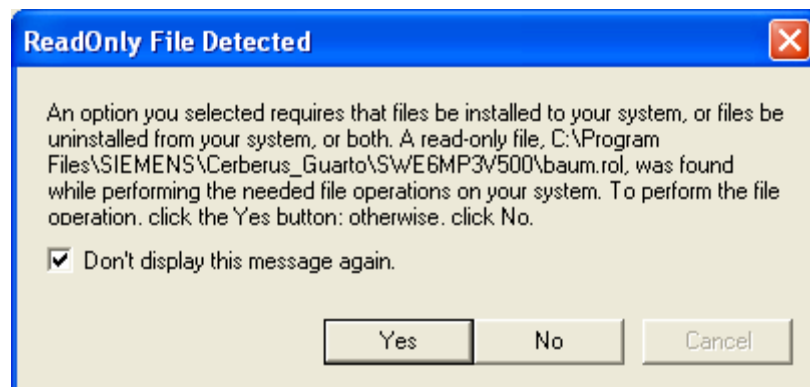
- Uninstall SWE6 MP3 V5.0
- Install SWE6 MP3 V5.0
 - When this message appears: click No
